MARYLAND GEOLOGICAL SURVEY Merryman Hall The Johns Hopkins University Baltimore, Maryland 21218 (301) 235-0771

COUNTIES (MD/PA)	WASHINGTON/FRANKLIN
M&D milestone no	93 (96)
MHT-HSI no.	WA-IV-093
	•

FIELD SHEET: MASON & DIXON LINE, MARYLAND-PENNSYLVANIA BOUNDARY MARKER SURVEY

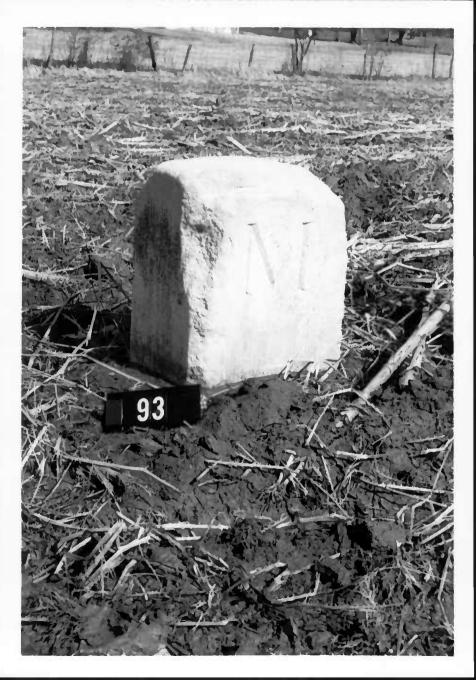
MA-TV-093
MAGORIE DINON WEST LINE: MILESTONE 93(96)

1979-81 Inspection notes: order no. 93 (96); photos/negatives/slides no. 93 (96) 93 (96). Original M&D milestone of 1767 in place, in good condition, firmly set. Letters and most embellishments distinct and intact. Large chips top edges and corners. Protected by owners, but vulnerable to damage by farm machinery.

MAGONE DIXON WEST LINE! HILLSTONE 93(96)
SW CORNER (- 11) LOOKING- FOR ALD
HARBAUCH CHURCH LIE MARTIN BAKN

As with many other MD-PA boundary monuments in the middle of cultivated fields: MGS will want to make arrangements for marking this monument so as to prevent further chipping by farm machinery. Most such damage is inadvertent, especially in corn fields where the monument is completely hidden during the growing season. Horace Waybright of Frederick County (M&D 78) solved this problem by a tail pipe with flag--tall enough to be seen above any crops.

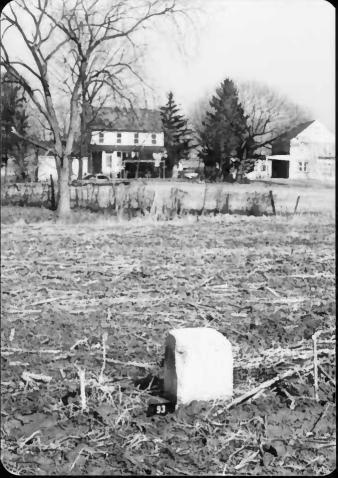
WM-1K-093 MES MID WESTLINE : MILESTONE 93(96) S/S OF STONE, LOOKING N ACROSS HARBAUGH CHURCH RD E MAUTIN HARMHOUSE PHOTO: ALICE MARTIN (1981.2.14. 2/15/34
